## Dredging Inspection Field Report

Date: 11/02/2021 Field Engineer: Mike Triano  
 Weather Conditions: Breezy, Overcast Temperature: 70s-80s  
 Wood Project Number: 2402210005.01.01 Client: Isle of Palms  
 Contractor: Branch Diversified (BDI) Foreman Onsite: N/A

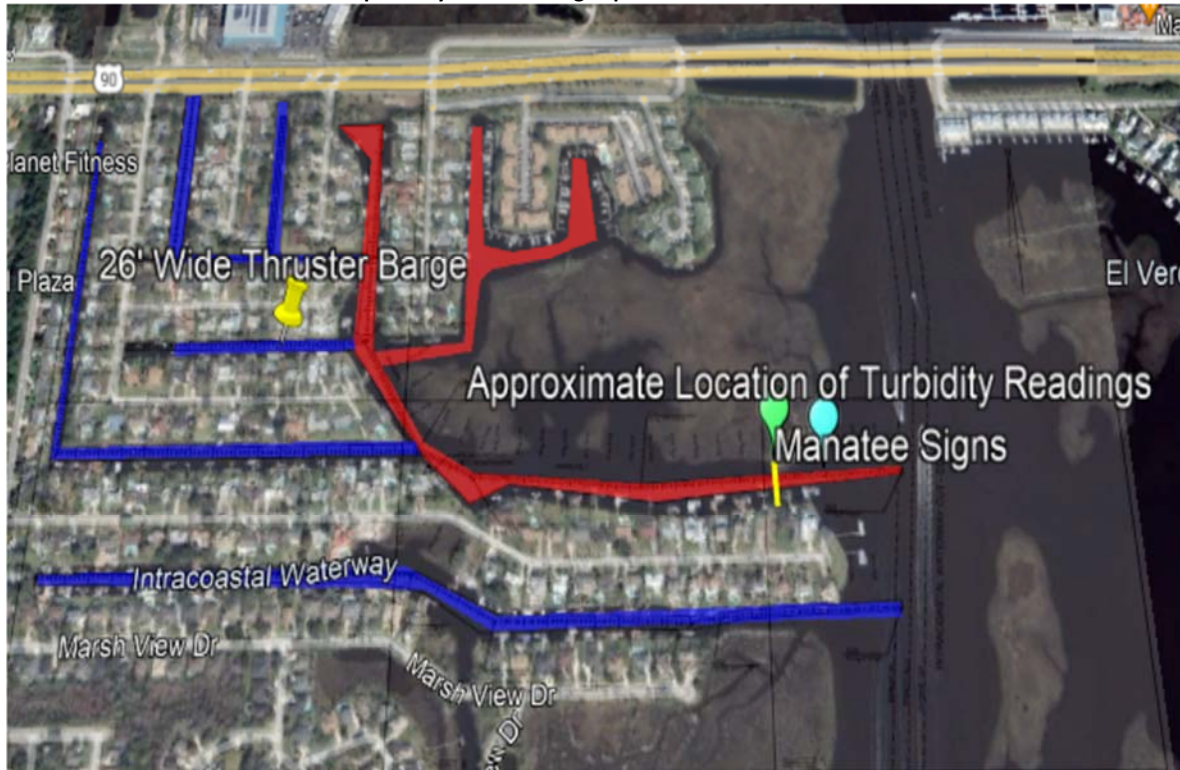
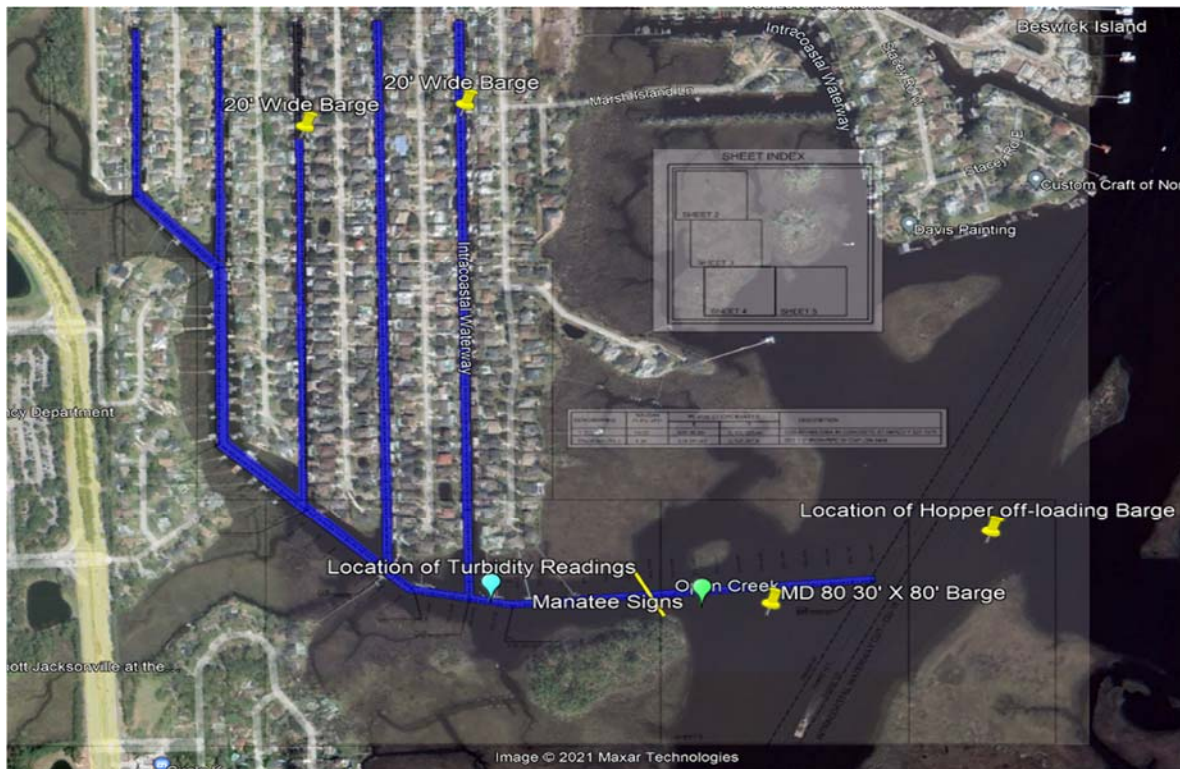
Maps: **Red** is completed Work **Blue** is Work to be completed

\*BDI will return to Canals to clean up survey identified high spots
