Dredging Inspection Field Report

Date: 3/6/2023
 Weather Conditions: Mostly sunny
 Wood Project Number: 2402210005.01.01
 Contractor: Branch Diversified (BDI)

Field Engineer: Mike Triano
 Temperature: 70s and Increasing
 Client: Isle of Palms
 Foreman Onsite: Lance Young

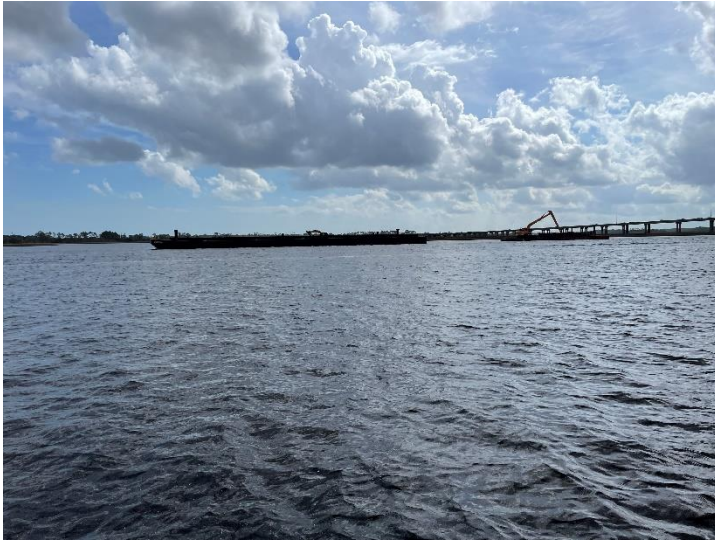
Photo 1:

Large Hopper Barge Moored in Intracoastal.

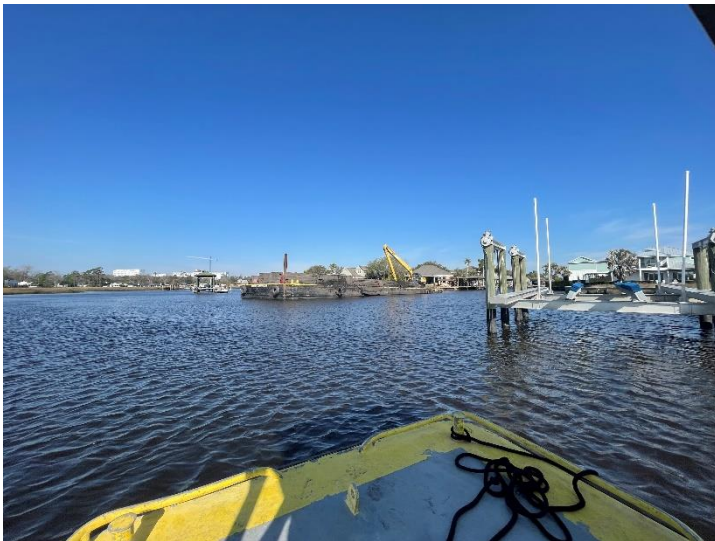
Photo 2:

MOBRO-908 staging barge Moored in Baseline 1, in front of Baseline 5.

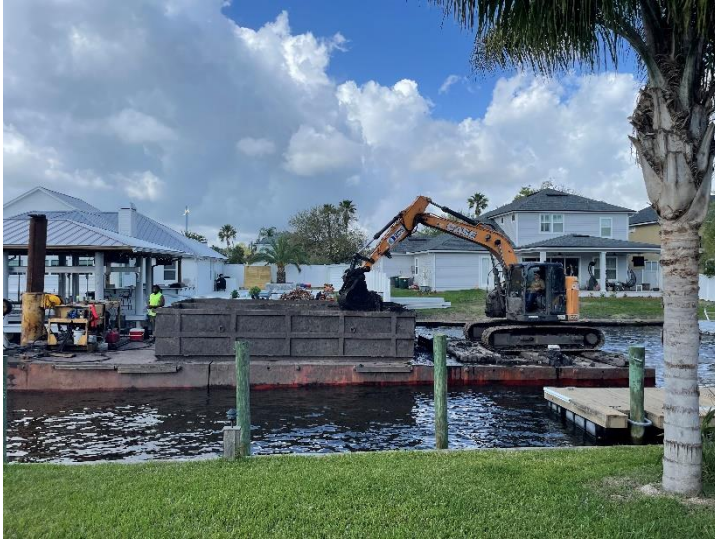
Photo 3:

View of 20' barge within Baseline 4.

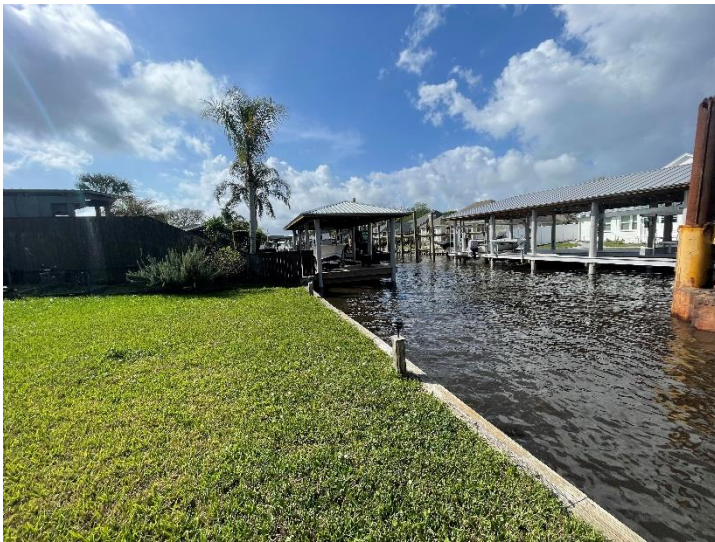
Photo 4:

View towards second 20' barge headed within Baseline 4. A third barge was actively being transported to this canal to continue dredging.

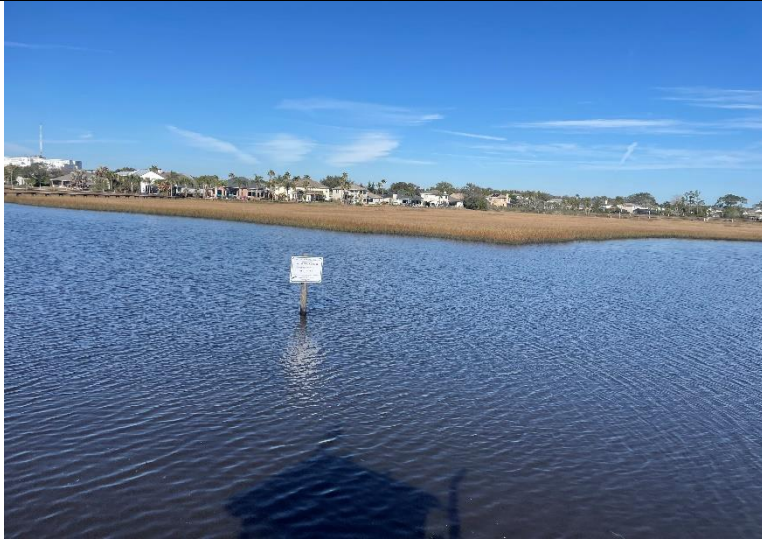
Photo 6:

Manatee Observer	All crew on barges were advised to keep eye out for Manatees - sign posted on northern and southern canals.	Photo: 5
Turbidity Monitoring	BDI indicated turbidity numbers for the day of the inspection (3/3) to be 19.2 NTU interior portions of work area and 15.7 NTU at the confluence of Intracoastal and work area.	Photo: N/A
Dewatering	Lance advised dewatering does not occur - drain holes are located in bottom of containers. Lance advised inner canals are mixing zones and therefore sediment/water returning to canals are not of concern.	N/A
Dredging	Mechanical	N/A
Offloading Location	<p>Large ~50' -100'+ Hopper barge – East of Baseline 1, southern IOP Canals.</p> <p>MOBRO-908 barge was utilized during the day to keep smaller barges in the canals and cut downtime, increase safety with boat</p>	1 & 2

Manatee Signs in place at entrance to Southern IOP canals.
