Dredging Inspection Field Report

Site Observations

Date: 6/1/2021 Field Engineer: Mike Triano
 Weather Conditions: Partly Sunny Temperature: 80s and Windy
 Wood Project Number: 2402210005.01.01 Client: Isle of Palms
 Contractor: Branch Diversidied (BDI) Foreman Onsite: Angel Guzman

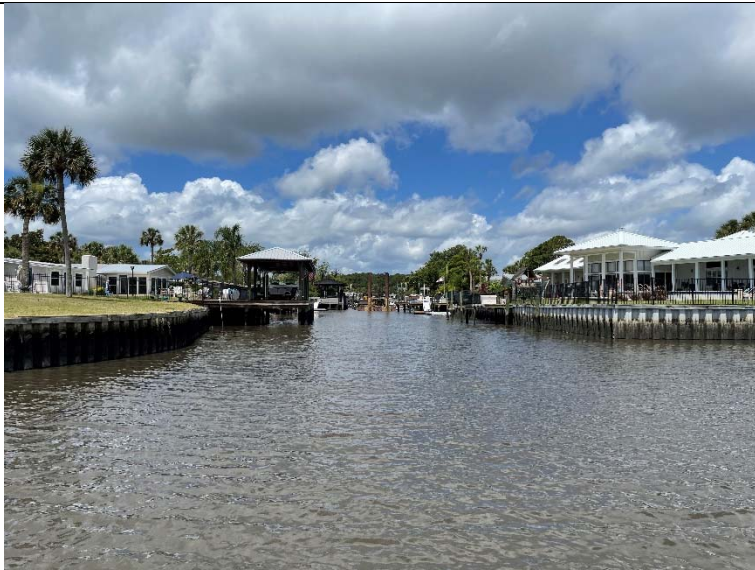
Photo 1: Barge actively dredging in Baseline 6 IOP District.

Item	Observations	Photo
Crew Size	<p>One 20' wide barge dredging at time of inspection within the IOP District. One additional 20' wide barge was dredging a portion of the "Autobahn Canal," adjacent to the Mooring Canals.</p> <p>Two tugs to move the barges back and forth.</p> <p>One 26' Thruster Barge – Not actively dredging at the time of the inspection</p> <p>One ~ 50' X 100'+ Hopper barge staged in intracoastal east of mooring canals used to transport material to DMMA.</p> <p>Angel's ~20' aluminum boat</p> <p>The 30' x 80' barge, typically located at Station 18, Baseline 1, was moored off to the large Hopper barge in the intracoastal at the time of the inspection. This barge was still being used to unload the smaller barges.</p>	<p>Photo: 1, 2, 6</p>
Location of Crew	<p>20' Wide barge located: actively dredging Baseline 6 IOP</p> <p>26' Wide Thruster barge: not actively dredging at the time of the inspection</p> <p>20' Wide barge located: Actively dredging in "Autobahn Canal"</p> <p>One ~ 50' X 100'+ Hopper barge staged in intracoastal east of mooring canals.</p> <p>The 30' x 80' barge, typically located at Station 18, Baseline 1, was moored off to the large Hopper barge in the intracoastal at the time of the inspection. This barge was still being used to unload the smaller barges.</p> <p>Angel's ~20' aluminum boat roams throughout</p>	<p>Photo: 1, 2, 6</p> <p>See Map</p>

Equipment on Site	<p>Same as Crew size, 4 mechanical dredges (excavators), and the inactive 26' Thruster Barge</p>	<p>Photos: 1, 2, 6</p>
Work Completed	<p>S Baseline 1 from POB to ~ Station 31</p> <p>Majority of N Baseline 1 to terminus - High spots remain: BDI indicated that any high spots identified will be corrected to the proper depth.</p> <p>Mooring Canals</p> <p>Portions of N Baseline 2, 3, 4, 5, & 6</p> <p>BDI indicated that the Mooring Canals are now fully completed.</p> <p>BDI indicated that the Autobahn Canal would take approximately 2 days to finish.</p>	<p>See Map</p>

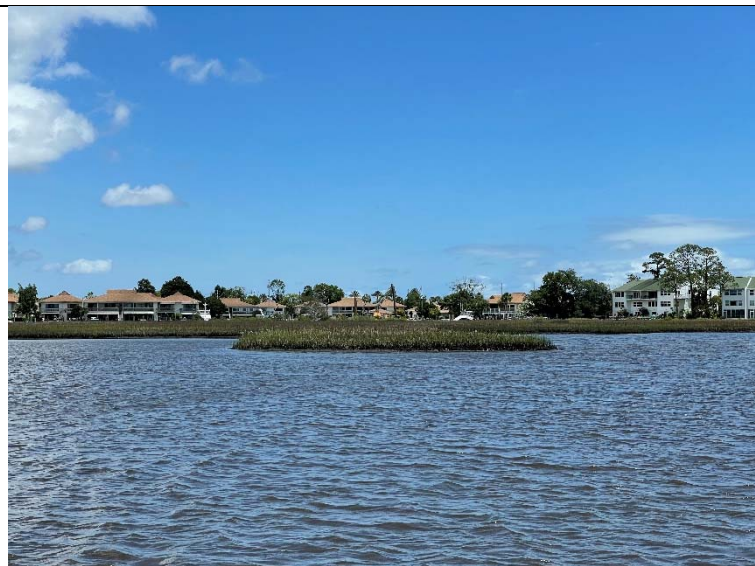
Photo 2: Photo towards Autobahn Canal, one 20' wide barge actively dredging – outside of the IOP District.

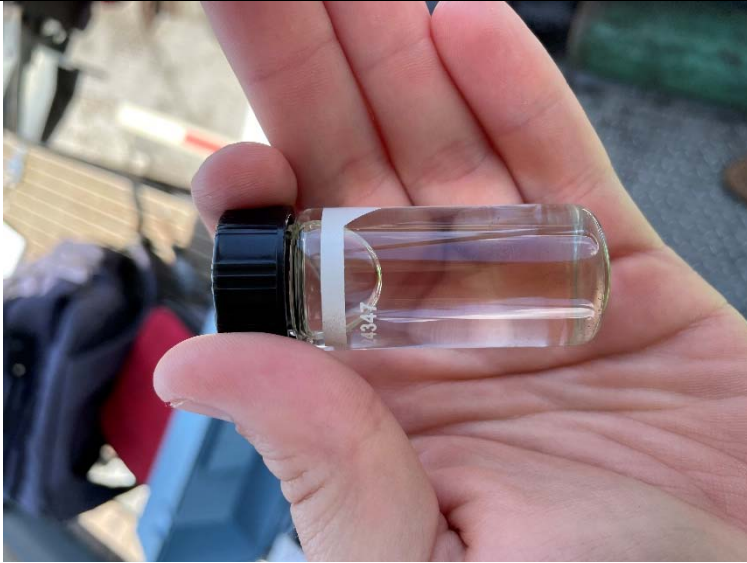
Photo 3: Typical photo of vial and water during the 1200 turbidity reading.

Turbidity Monitoring	<p>0800 reading was 6.45 NTU 1200 reading was 11.50 NTU – taken at the time of the inspection.</p> <p>Barrier was open at the time of the inspection.</p>	Photos: 3
Dewatering	Lance advised dewatering does not occur - drain holes are located in bottom of containers. Lance advised inner canals are mixing zones and therefore sediment/water returning to canals are not of concern.	N/A
Dredging	Mechanical	
Offloading Location	<p>Large ~80 -100+ foot storage barge located in the Intracoastal. Angel advised that there are several barges of this size, and larger that are interchanged once full.</p> <p>The 30' x 80' barge, typically located at Station 18, Baseline 1, was moored off to the large Hopper barge in the intracoastal at the time of the inspection. This barge was still being used to unload the smaller barges.</p> <p>Angel advised that trips to the DMMA are taken once these large barges are full, but that usually occurs once a day.</p>	Photo: 6

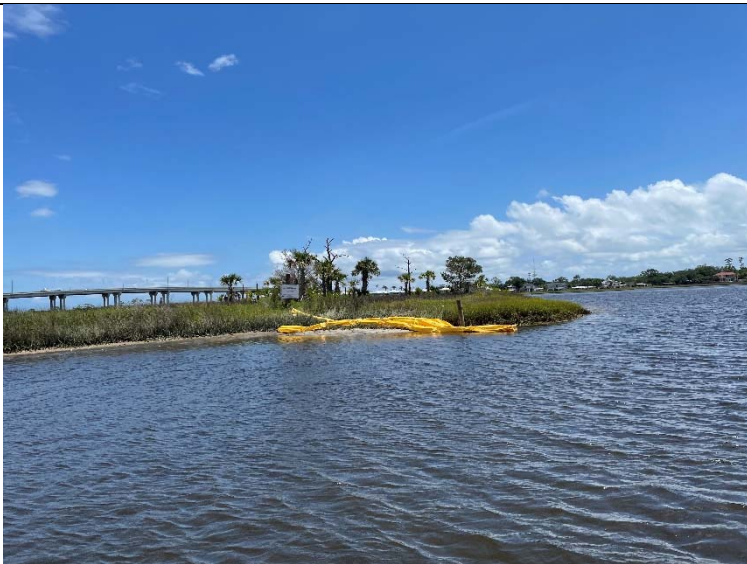
Photo 4: Typical turbidity barrier and manatee signs

<u>BDI advised dredging occurs in two phases: on the way in for access & removal of top layer of sediment and on the way out for getting canal to specified grade. This is true for all canals that barges cannot initially access.</u>	
Work Underway	Dredging of Baseline 6 within the IOP District Dredging of Autobahn Canal outside of the IOP District	See Map
Materials on Site	<p>Stored in ~100'+ long X 50' wide Hopper barge and One 30' x 80' barge. Both barges were moored in the intracoastal at the time of the inspection.</p> <p>The 30' x 80' barge, typically located at Station 18, Baseline 1, was moored off to the large Hopper barge in the intracoastal at the time of the inspection. This barge was still being used to unload the smaller barges.</p> <p>Angel advised that trips to the DMMA are taken once these large barges are full, but that usually occurs once a day.</p>	Photo: 6
Manatee Observer	All crew on barges were advised to keep eye out for Manatees - signs posted on northern and southern canals.	Photos: 4

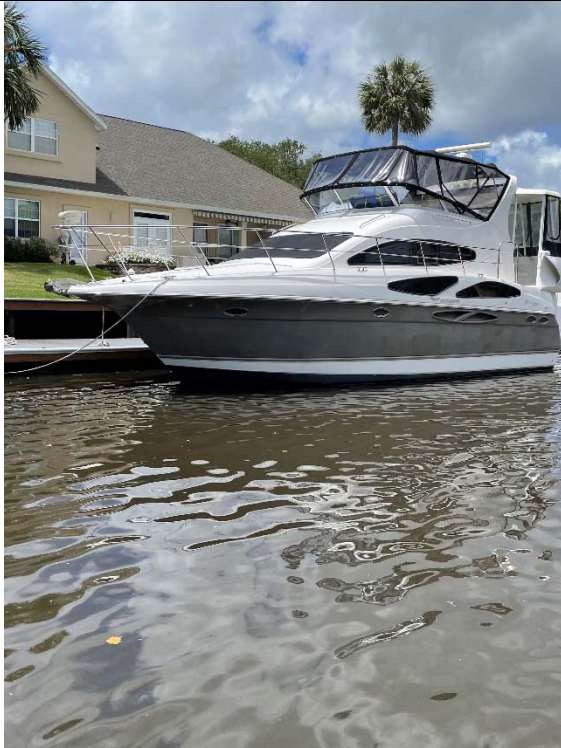
Photo 5: Large vessel blocking access to Baseline 5.

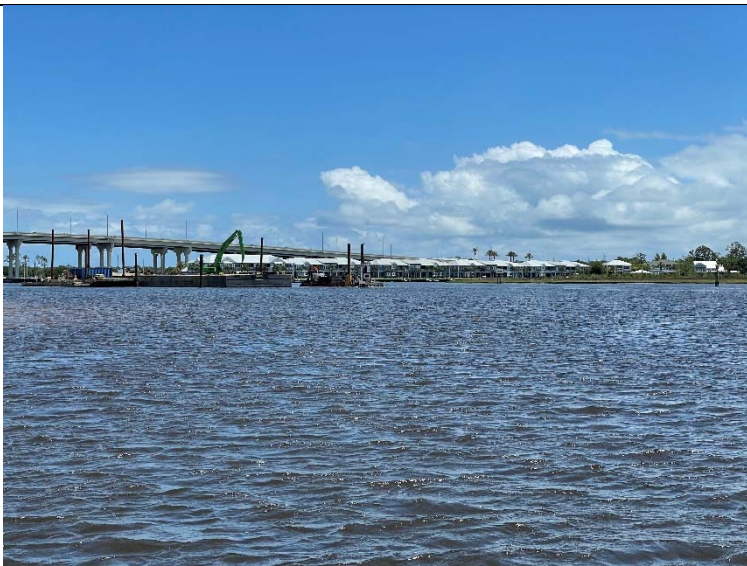
Photo 6: Typical view of offloading point for the smaller barges.
