## Dredging Inspection Field Report

### Site Observations

Date: 7/21/2021 Field Engineer: Mike Triano  
 Weather Conditions: Breezy, overcast, scattered Thunderstorms Temperature: 80s  
 Wood Project Number: 2402210005.01.01 Client: Isle of Palms  
 Contractor: Branch Diversified (BDI) Foreman Onsite: Lance Young

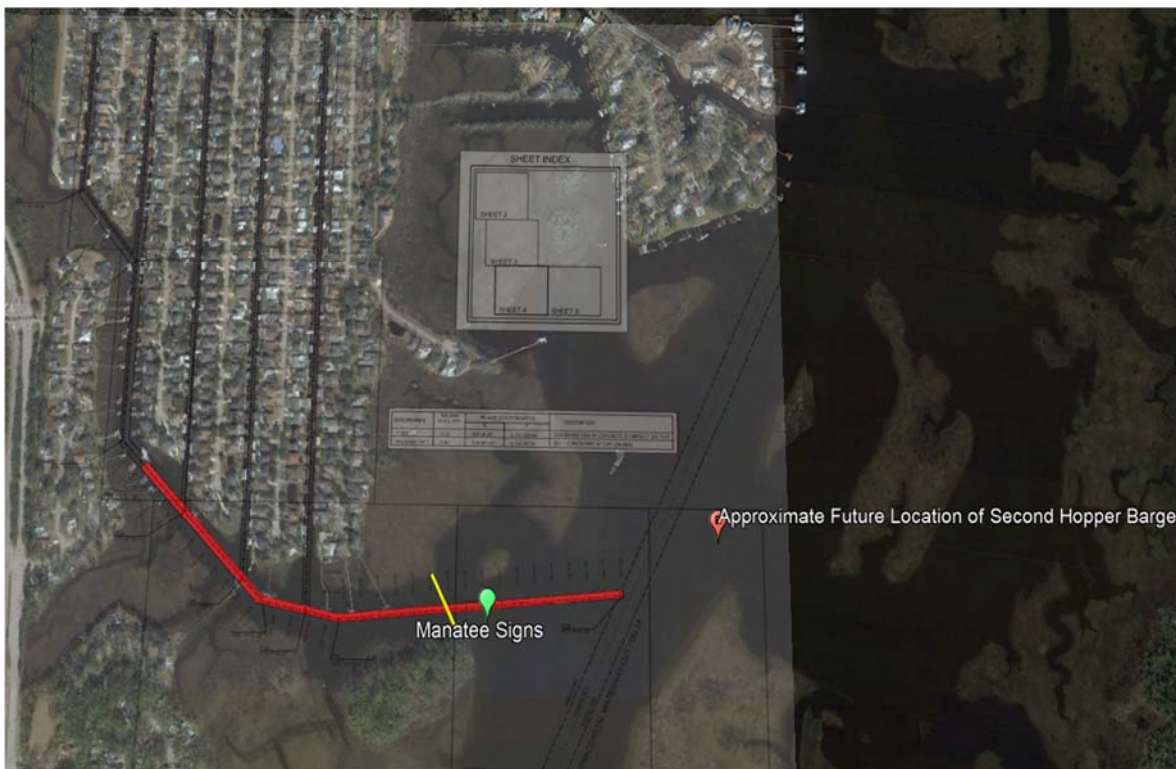
Maps: **Red** is completed Work **Blue** is Work to be completed

| Item | Observations | Photo |
|---|--|--|
| <b>Work Completed</b> | <p>S Baseline 1 from POB to ~ Station 31<br/>Majority of N Baseline 1 to terminus:<br/>Correction of High Spots within Baseline 1 was occurring at the time of this inspection with 26' Thruster Barge</p> <p>Mooring Canals<br/>Portions of N Baseline 2, 3, 4, 5, &amp; 6</p> <p><u>BDI advised dredging occurs in two phases: on the way in for access &amp; removal of top layer of sediment and on the way out for getting canal to specified grade. This is true for all canals that barges cannot initially access.</u></p> | See Map |
| <b>Work Underway</b> | Baseline 1<br>Baseline 7 | See Map |

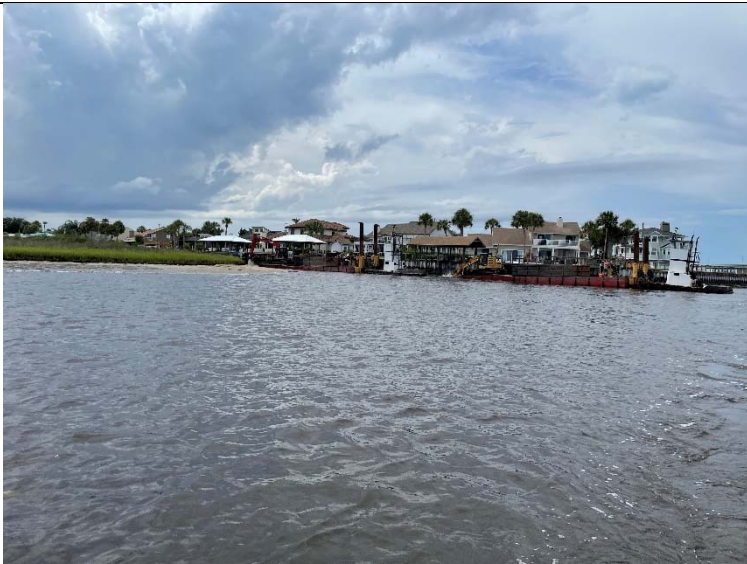
**Photo 1:** View of two 20' wide Push Barges actively dredging Baseline 7.

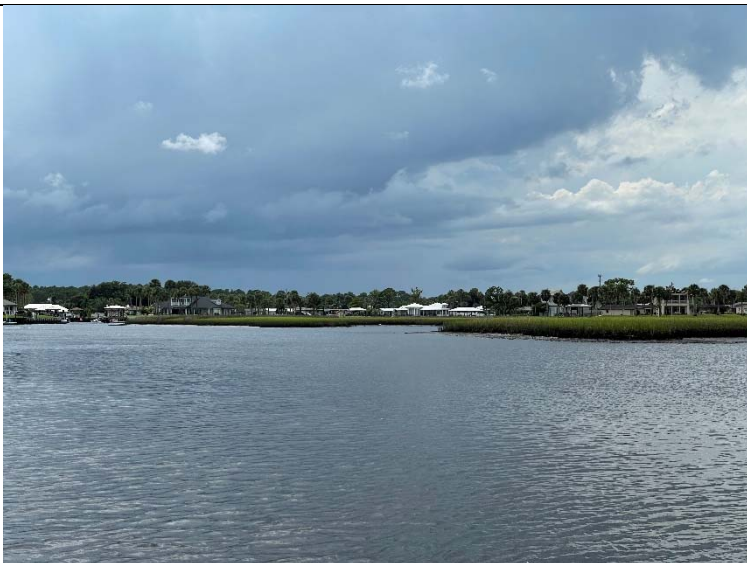
**Photo 2:** View of Thruster Barge (in the distance) heading back into Baseline 1 to continue re-work of high spots previously identified.

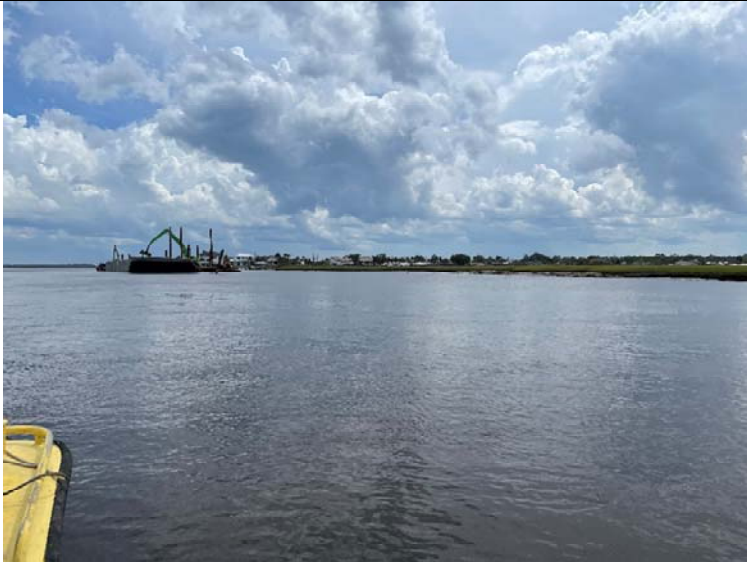
**Photo 3:** View of 20' Push Barge being off-loaded.

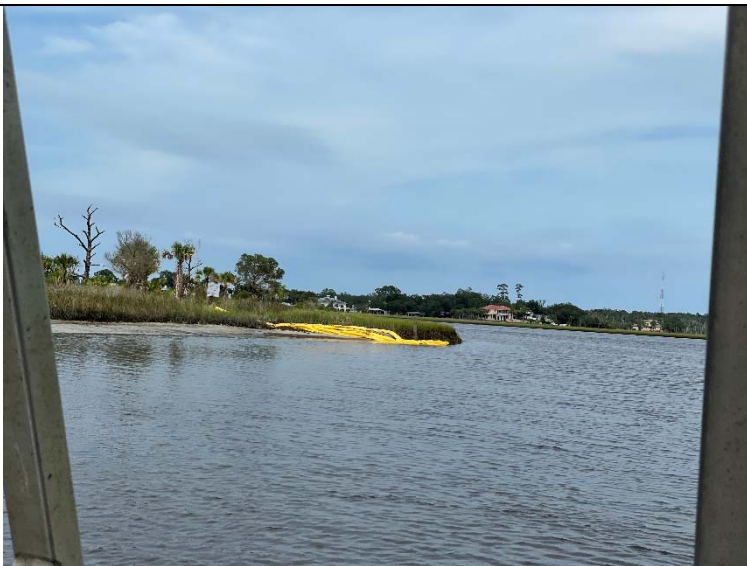
| Item | Observations | Photo |
|---|--|--|
| <b>Manatee Observer</b> | All crew on barges were advised to keep eye out for Manatees - signs posted on northern and southern canals. | Photos: 4 |

**Photo 4:** Typical view of turbidity barrier and manatee signs.

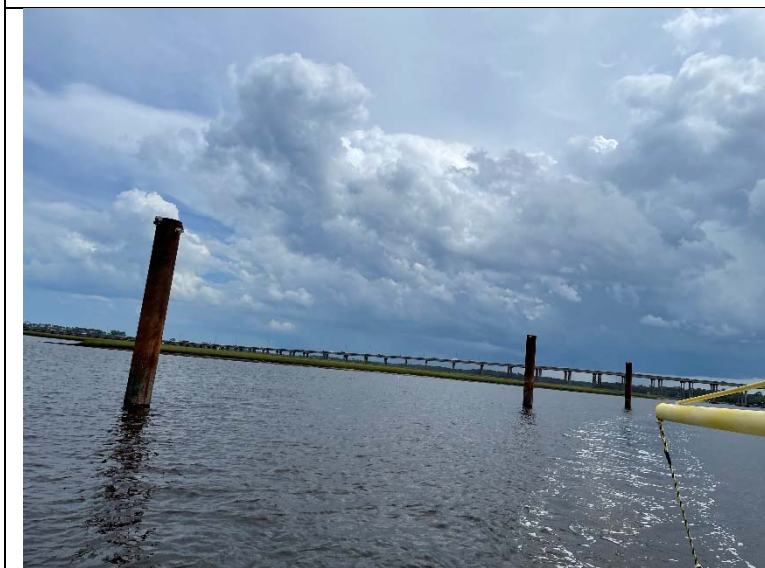
**Photo 6:** Future location of ~50' Wide x 100' Long hopper barge.

**Note:** Solar lights on the top of the pilings.
